AVIATION INVESTIGATION REPORT

A00W0109

LOSS OF CONTROL—STALL

AERIAL RECON SURVEYS
CESSNA 177B CARDINAL C-GPML
CALLING LAKE, ALBERTA
30 MAY 2000

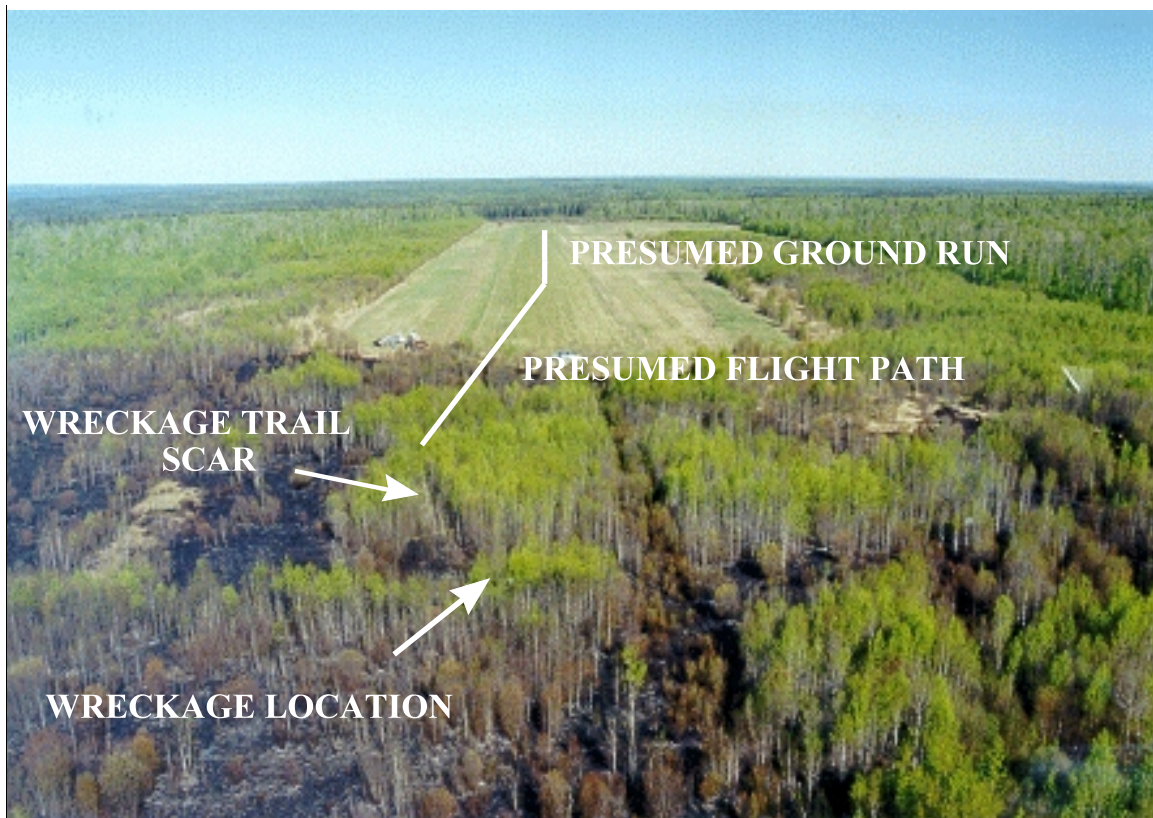
Appendix B – Calling Lake Aerodrome

had originally been provided at the departure end of runway 10.³ The clearway for runway 10 had not been maintained since the aerodrome was originally constructed, and it contained second-growth trees that were estimated to be up to 30 feet tall. Transport Canada regulations do not require clearways to be provided, or to be maintained devoid of vegetation, at a registered aerodrome.

1. The aircraft was not fitted with a crashworthy fuel system design that might have prevented or reduced the intensity of the post-crash fire, nor is it required on new or existing aircraft models by existing regulation.
2. There is no requirement for the clearways at a registered aerodrome to be maintained clear of vegetation; the original clearway zone at the departure end of runway 10 was overgrown with brush and trees up to approximately 30 feet in height.

Aerial view of Calling Lake aerodrome looking west

Following this occurrence, the aerodrome operator removed the trees on the clearway at the departure end of runway 10 at the Calling Lake aerodrome.
